Skyland Fire Hydrant Status

Fire Hydrants

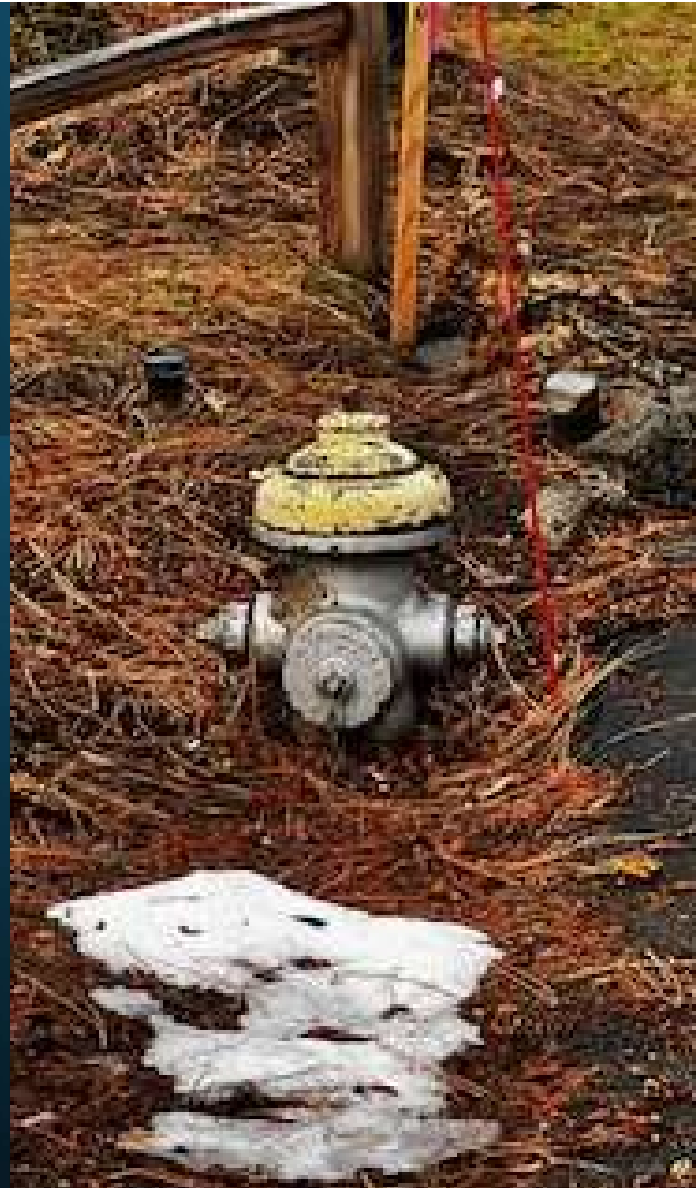
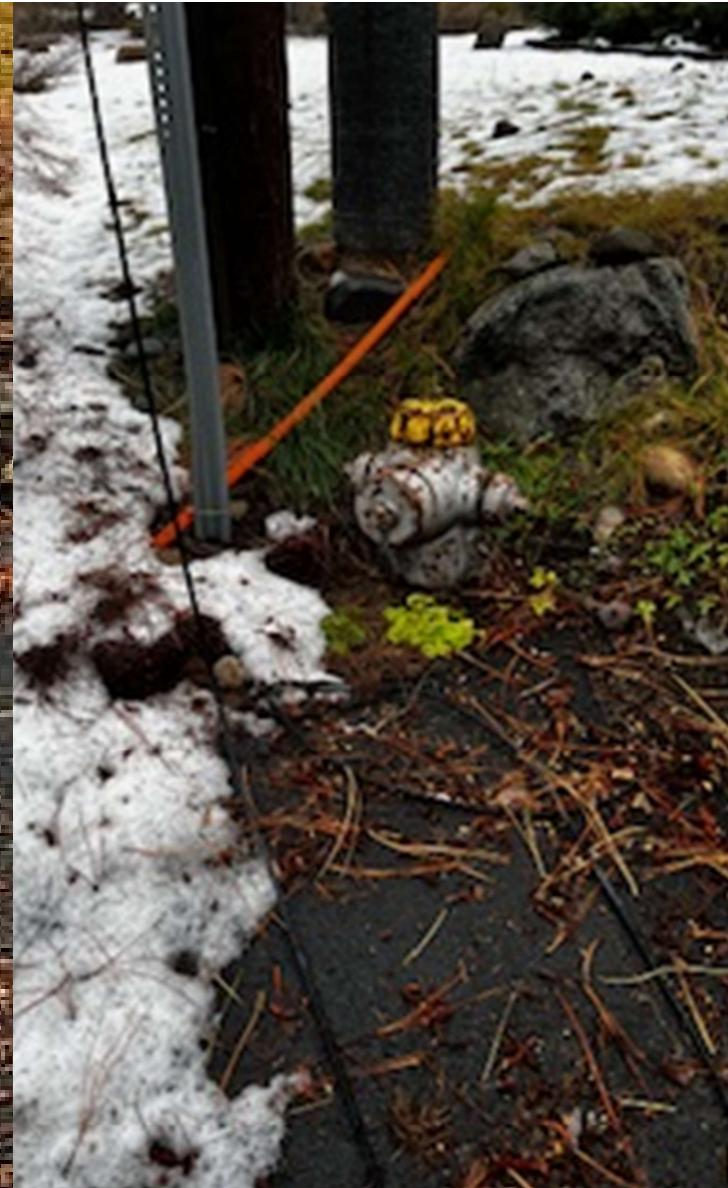
- There are 21 Fire Hydrants in Skyland.
- 7 Fire Hydrants appear to be original to the neighborhood (late 50's, early 60's style).
- 8 Fire Hydrants do not meet code because they are too low to the ground.
- 1 Fire Hydrant has the wrong main valve diameter (4" vs 6")
- The colors (base or cap) do not meet the current standard to aid critical firefighter timelines

1. Letter to Water Utility and TDFPD identifying the issues found and requesting resolution
 - Potential FH replacement
 - Potential addition of riser
 - Potential painting of FH w/ cap color correlated to flow rate
